MALLARD BAY: GEOTECHNICAL REPORT AND CRITICAL AREAS STUDY

SE 43rd Way and East Lake Sammamish Parkway
Issaquah, Washington

Project No. 1667207

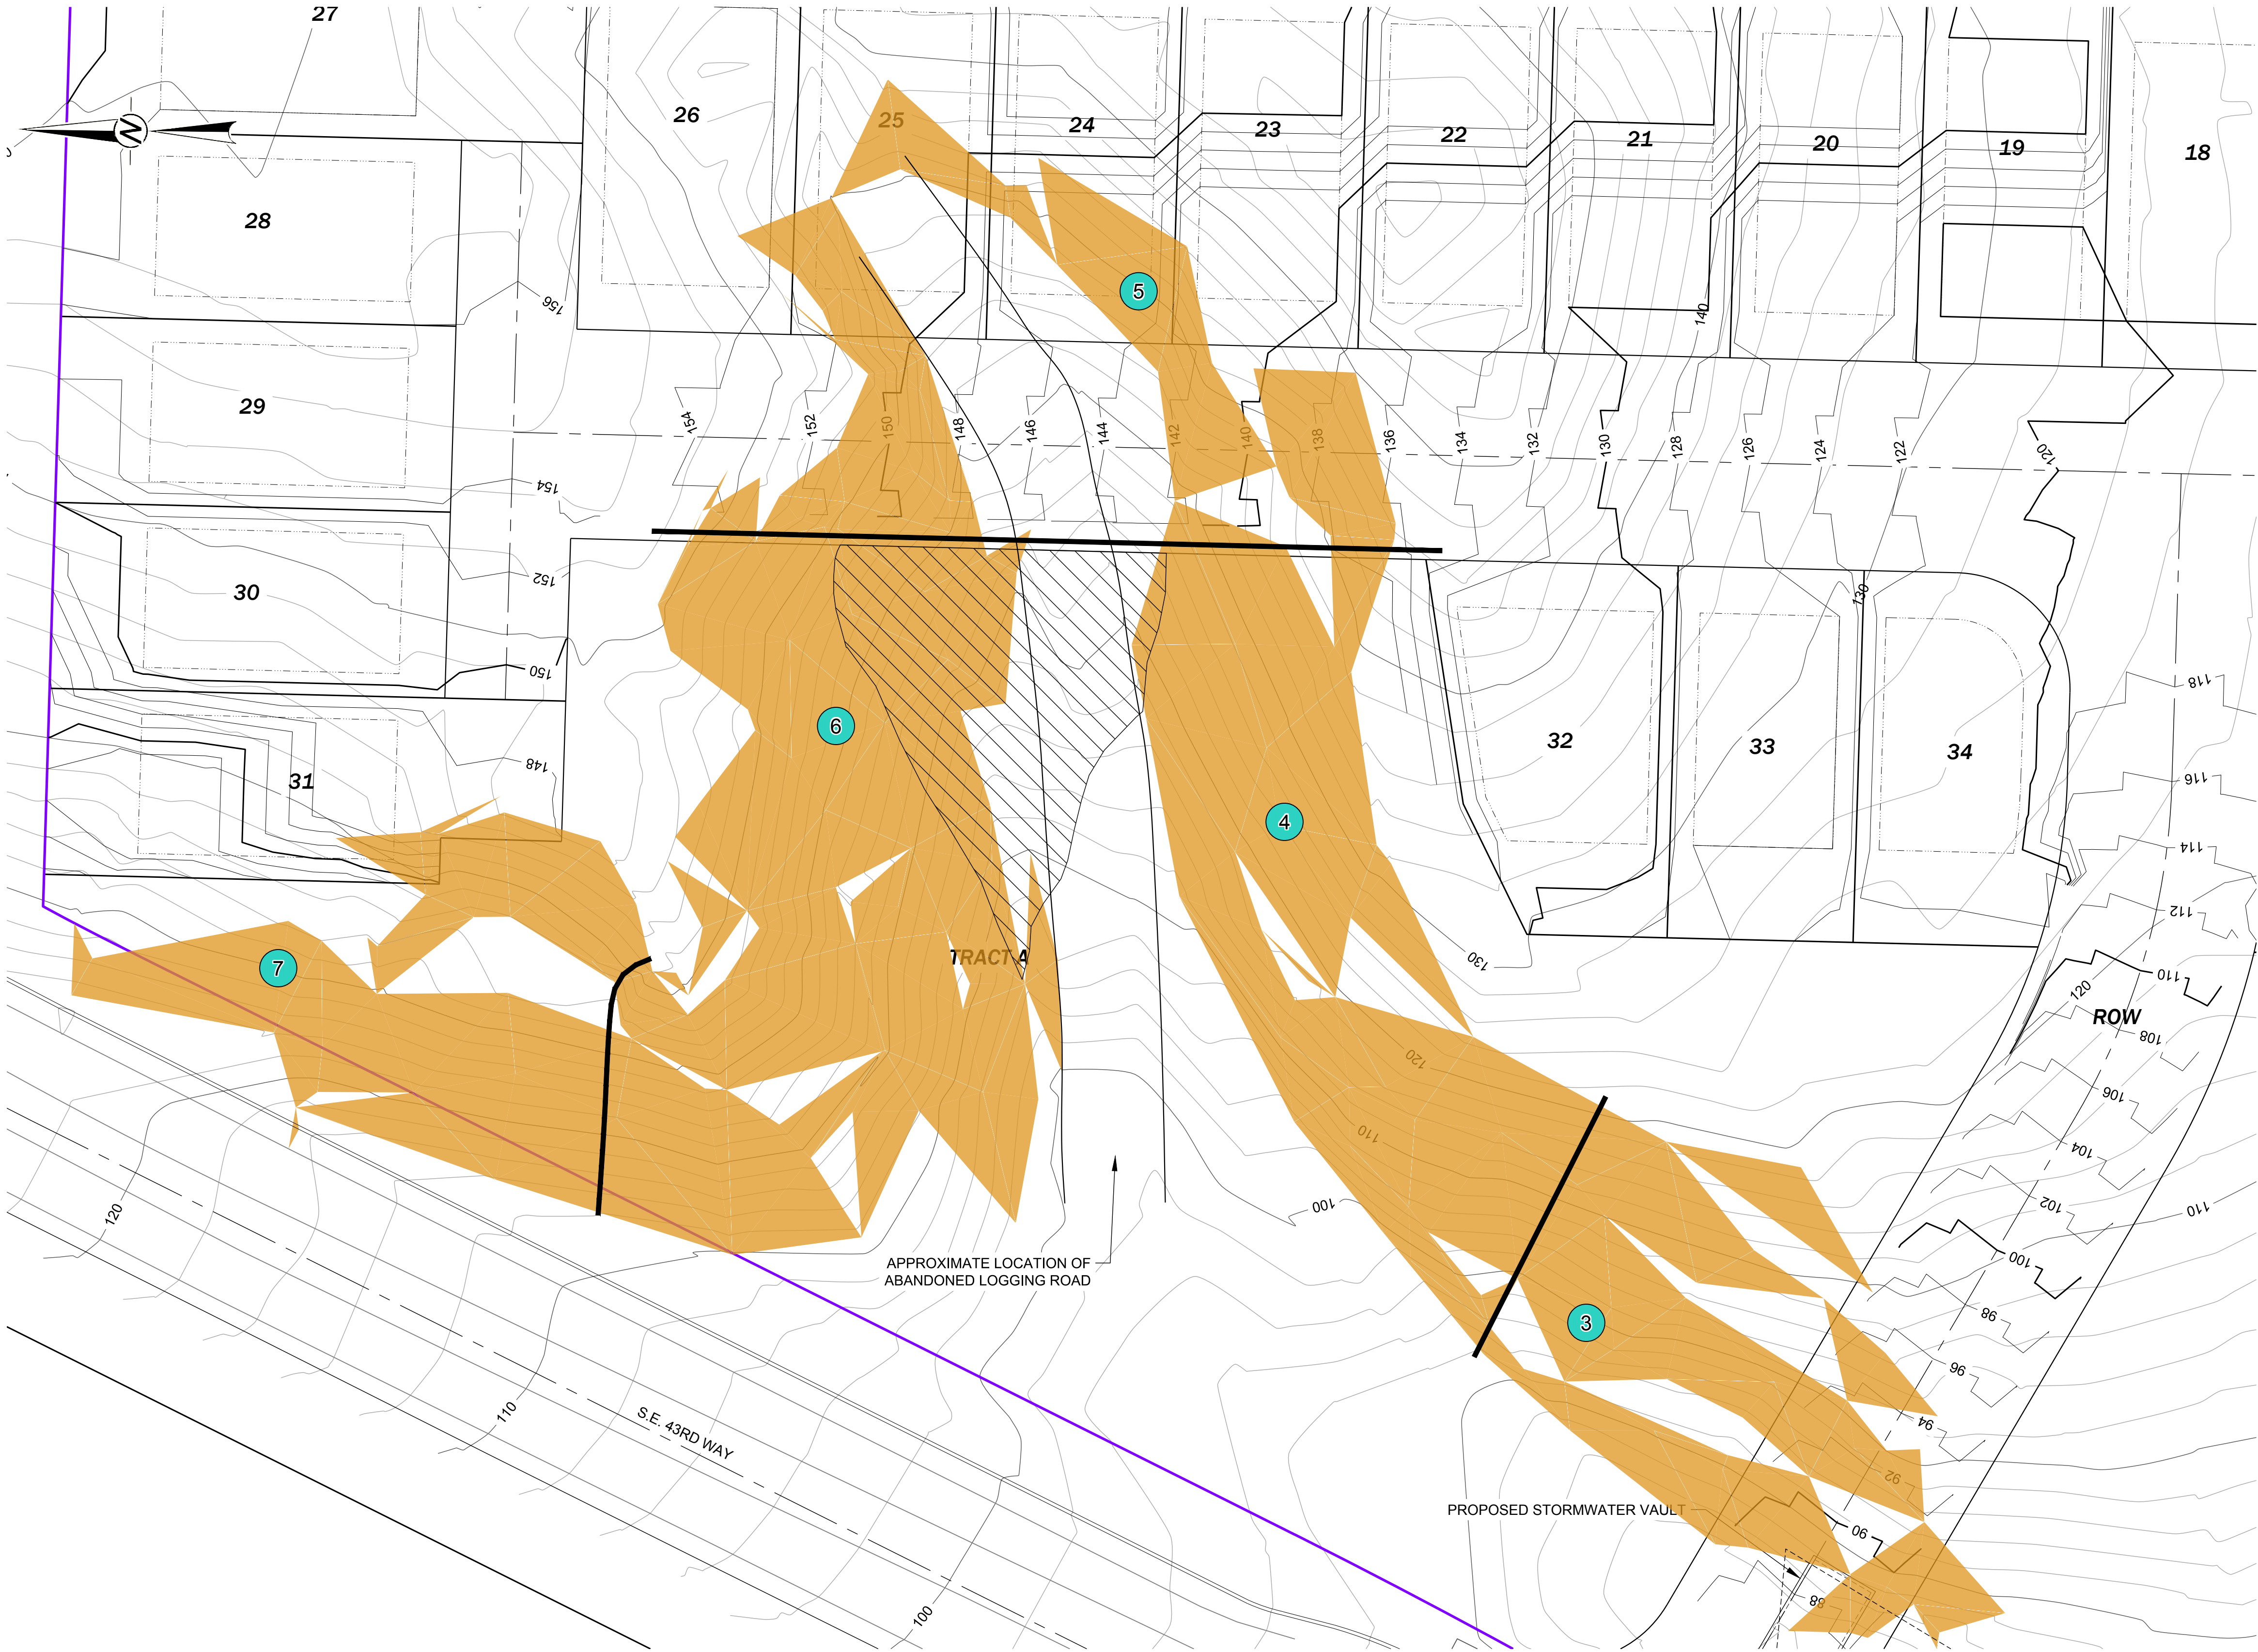
TITLE STEEP SLOPE AREAS (NORTH)
REDMOND OFFICE 18300 UNION HILL RD SUITE 200 REDMOND, WA 98052 COUNTRY [+1] (425) 883-0777 www.golder.com	PROJECT NO. 1667207
	PHASE 100
	REV. 0
	EXHIBIT A1

Steep slope hazard areas are defined in the IMC as any ground that rises at an inclination of 40% or more within a vertical elevation change of at least 10 feet. The project civil engineer (Core Design) produced a topographic exhibit that includes all the site slopes that meet the steep slope hazard definition (Exhibits A1 and A2). The delineated steep slope hazard areas on Exhibits A1 and A2 have been numbered for purposes of discussion in this report (1 to 7) starting at the south end of the site. All of the steep slopes lie along the same continuous slope that wraps around the south and west boundaries of the upland area of Mallard Bay. The steep slopes at the south end of the site range from about 70 to 80 feet elevation at the toe to 94 feet at the crest. The steep slopes along the west portion of the site and bordering the shallow ravine containing the logging road range between about 100 to 130 feet elevation with a very minor area at the head of the ravine between 140 to 150 feet elevation. Each of the slopes is described below.

The Mallard Bay development plan proposes to re-grade and flatten the portions of Slope #1 between 10 and 20 feet in height as part of lot grading for Lots #3 and 4 (Figure 2). The resultant slope condition will be more stable (less steep) than the current slope condition. In accordance with IMC 18.10.580 paragraph E "Limited Exemptions", the applicant is requesting an exemption from the steep slope critical
